# Marina DOCK AGE

## Inlet Watch Yacht Club seawall weeps to relieve pressure

The seawall at Inlet Watch Yacht Club in Wilmington, N.C., is a myriad patchwork of materials of varying ages, but it lines the protected basin in the 20-acre resort as a solid structure.

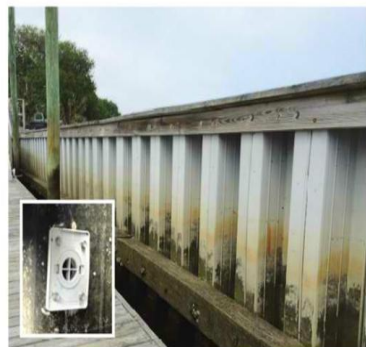
Inlet Watch Yacht Club has approximately 280 weep hole filters by Jet Filter Systems that drain water from behind the retaining wall.

Recently, Inlet Watch Yacht Club installed 130 additional Jet Filters in its 650-foot vinyl bulkhead. That puts one weep hole about every five feet. In that area around the coast of North Carolina, especially around the root systems of live oaks, the soil often holds pockets of water. "We'd drill for one hole and find no water," Moore said. "Others, we'd have a gusher."

The secret to the filter and what allows water to escape and keeps soil and sediment in is the filter material (Miraf<sup>®</sup> from LenCate Geosynthetics). The geotextile is composed of polypropylene yarns, which are woven in such a way that they retain their relative position—in other words, the filter doesn't wear out and it doesn't get clogged with soils and sands.

Depending on the amount of water and the soil composition, the filter may need to be cleaned, if it's not weeping effectively, Gentry recommends checking the holes annually. Many will never have an issue. About every three years, depending on the soil composition, some filters may need cleaning with a pressure-washer or cleaning solvent. They will always retain their integrity
