## Failing Seawalls Relieve Hydrostatic Pressure with Weep Holes

by Sean Goforth

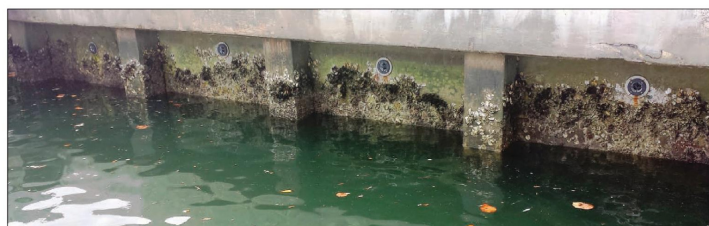
Lake Park Marina in Lake Park, Florida (not shown here), renovated its failing seawall with 150 weep holes from JET Filter. The weep holes relieve hydrostatic pressure behind the wall, providing a mechanism for water to drain through the seawall.

of failure if there is not an adequate release valve through which the water can escape. One way of addressing this challenge is to create weep holes in order to reduce the hydrostatic water pressure behind the seawall. The weep holes allow the water to escape while, at the same time, weep holes that are properly fitted with filters can trap the soil from the coast side and thus prevent soil erosion. Properly functioning weep holes should allow for drainage of water through the seawall to the body of water and prevent the loss of soil.
